### LAKE DEERWOOD PROPERTY OWNERS ASSOCIATION

March 2016 Damage to Lake Deerwood Dam

(TX03582) Harrison County, Texas

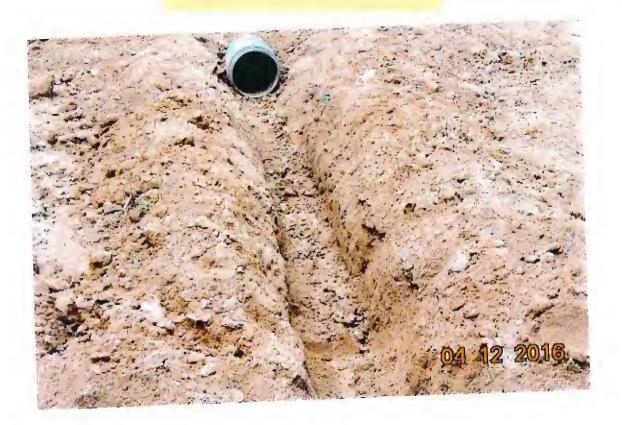
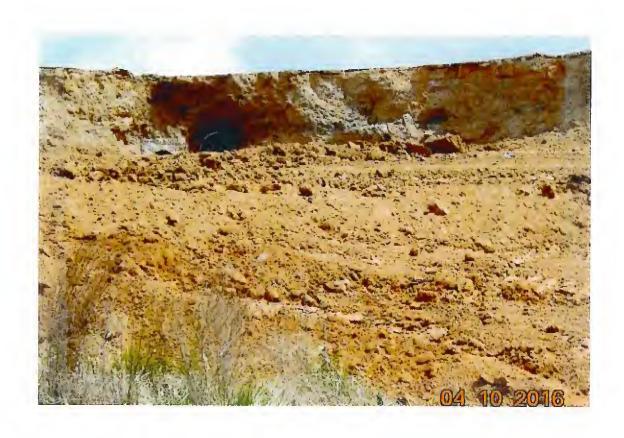
Packed Clay and

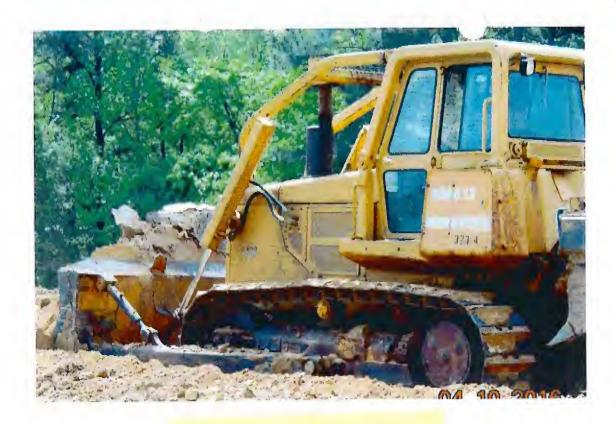
Packed Clay ALD

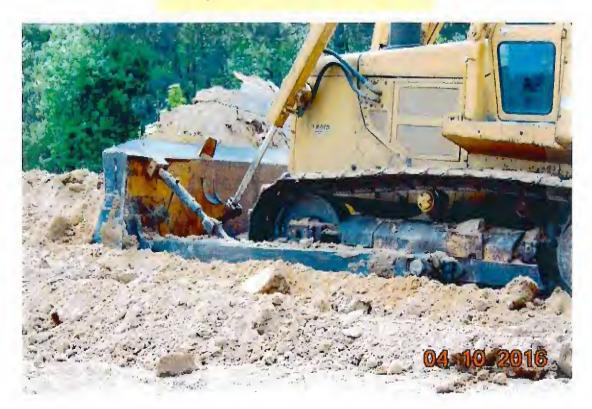
Clay our From car

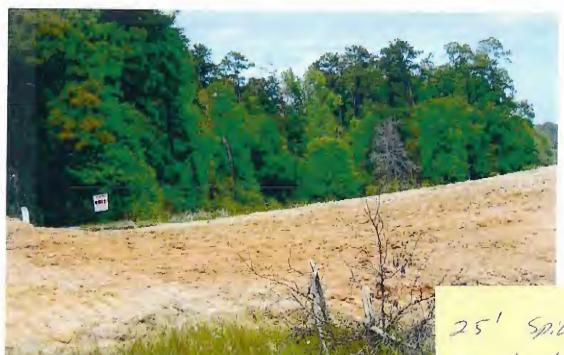
25' Spil Lury

or Sept Sime

Of Dance (lay our)

There can to be cover

with I" Top Soil to

grow gross

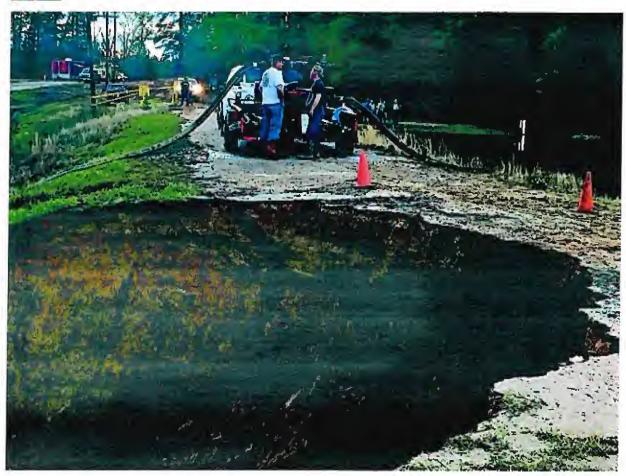
HARLETON - The dam at Lake Deerwood continued eroding Friday due to the recent heavy rainfall according to Fire Marshal Thomas Mock.

"More has given way," Mock said, describing the earthen-wall dam that was slowly eroding away on the backside facing Liberty Road. "It will probably finally give way. It's slowly eroding away."
